Manhole Inspection Summary

Manhole # S27C1_001MH

Insp Date: **4/16/08 12:50 PM**

Location Address: **BEHIND 2329 ANNAPOLIS RD**

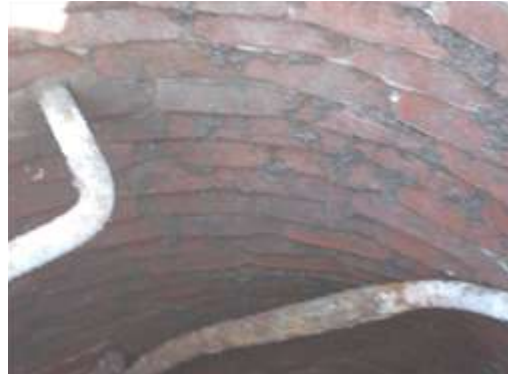
Defect 2

Infiltration: ☐ None ☐ Joint ☐ Cracks ☒ **Mortar** ☐ Roots ☐ Wall

EVIDENCE OF CORBEL AND BARREL INFILTRATION

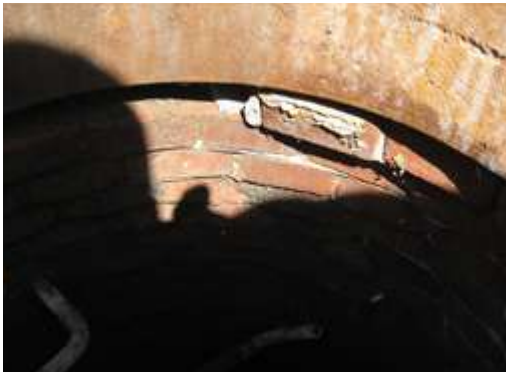
Defect 1

Condition: ☐ Sound ☐ Cracked ☐ Root Intrusion ☒ **Loose Brick** ☒ **Deteriorated**

MISSING MORTAR AND BRICK WITH EVIDENCE OF CHIMNEY INFILTRATION

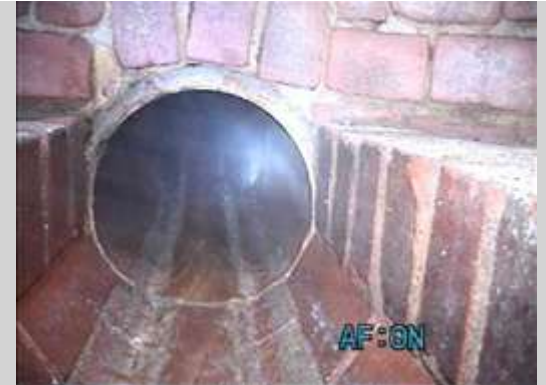
12 O'Clock Outflow

8 in. Circular Gravity Sewer
Pipe Out @ 12 O'Clock

Pipe Height: **8.4** (in.) Rod and Bar (Angled)
Pipe Material: **Clay** ☐ Pipe Lined
Invert Depth: **7.39** (ft.) Flow Characteristics: **Slow**
Deposits: ☒ None ☐ Mud ☐ Sludge ☐ Debris ☐ Grease
Silt Depth: **0** (in.) Deposits Extent:
Infiltration: **None** Pipe Seal Cond: **Sound**

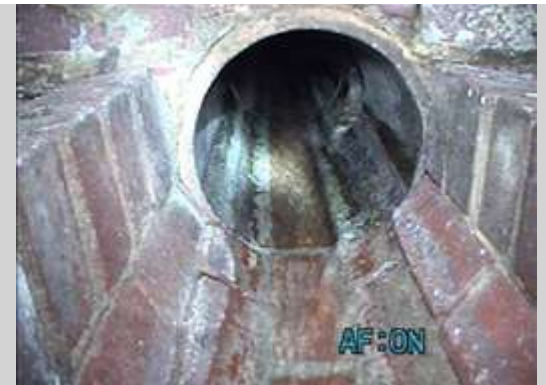
6 O'Clock Inflow

8 in. Circular Gravity Sewer
Pipe In @ 6 O'Clock

Pipe Height: **8.4** (in.) Rod and Bar (Angled)
Pipe Material: **Clay** ☐ Pipe Lined
Invert Depth: **7.30** (ft.) Flow Characteristics: **Slow**
Deposits: ☒ None ☐ Mud ☐ Sludge ☐ Debris ☐ Grease
Silt Depth: **0** (in.) Deposits Extent:
Infiltration: **None** Pipe Seal Cond: **Sound**
